Technical Report HL-96-18  
September 1996

# Channel Stability Study, Flamingo Wash, Las Vegas, Nevada

Prepared for U.S. Army Engineer District, Los Angeles

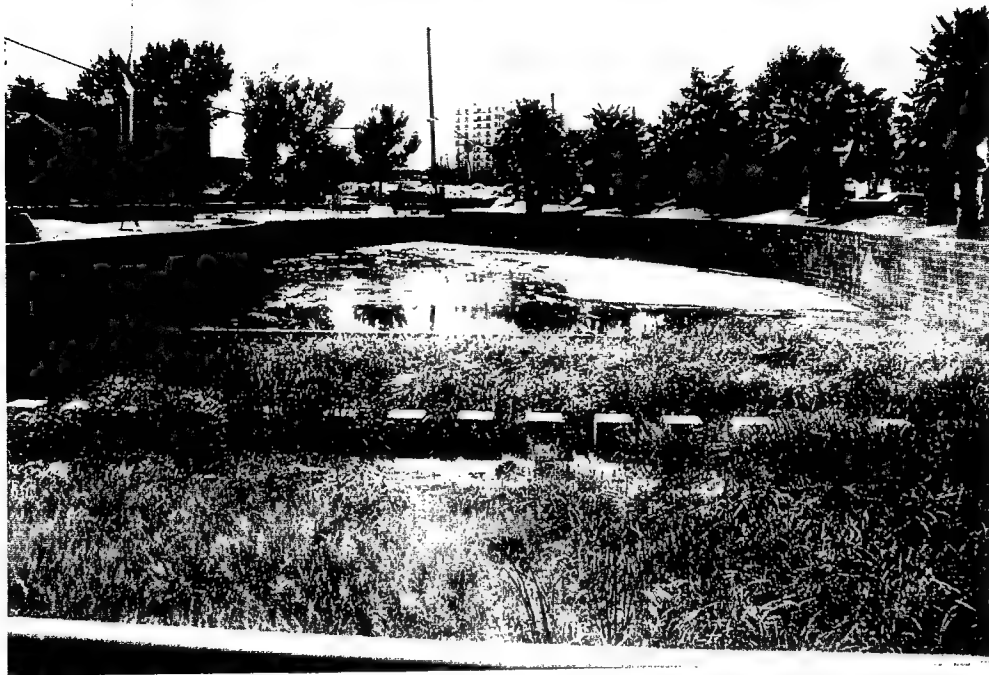
Downstream from Harmon Avenue, for about 150 ft, the channel was concrete-lined. At the end of the concrete-lined channel there was a 3- to 4-ft drop structure and an energy dissipator (Figure 2). Downstream from the dissipator the channel was grass-lined. Low vegetative ground cover was maintained on the side slopes between a driveway bridge, located about 250 ft downstream from Harmon Avenue, and a point 900 ft downstream from Harmon Avenue (Figure 3). Downstream from that point, both the invert and side slopes were grass-lined. Most of the grass in the channel was well maintained in August 1994, but there were a few spots where it had died and bare ground was exposed. Underneath the driveway bridge there were large cobbles and boulders that looked like they had been positioned to hold the low-flow channel. A paved dip road crossing was located about 600 ft downstream from Harmon Avenue. The grass-lined channel runs into a concrete multi-bay culvert which is located 1400 ft downstream from Harmon Avenue. The features described for reach 2 are shown in Plate 4.

Figure 2. Tropicana Wash - Reach 2, looking upstream at concrete-lined exit from Harmon Avenue culvert from driveway bridge, August 1994

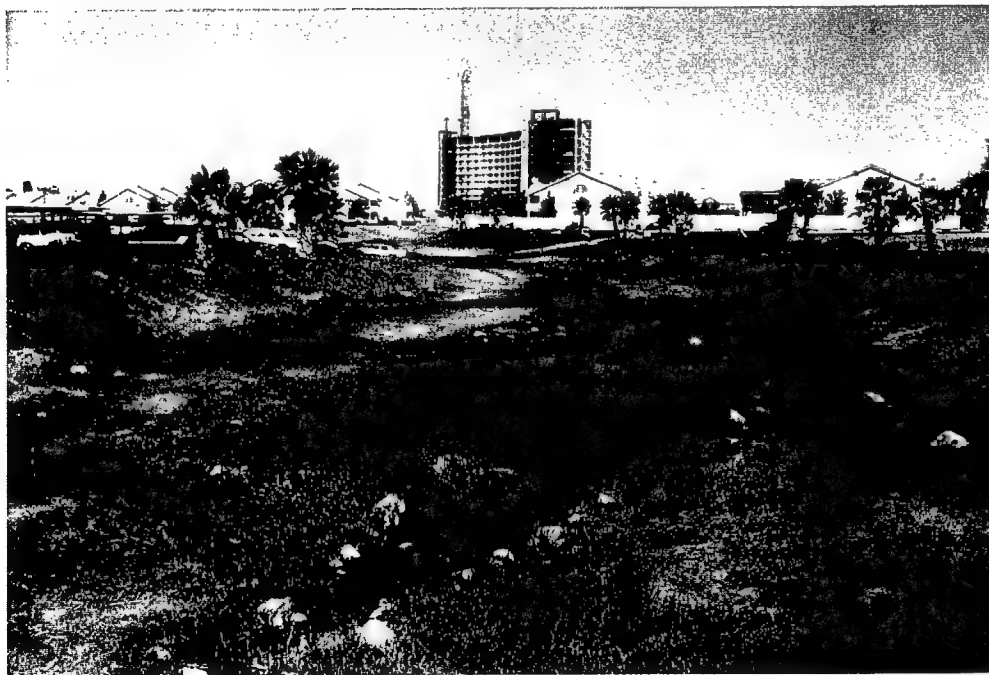
Figure 3. Tropicana Wash - Reach 2, looking downstream from driveway bridge which is 250-ft downstream from Harmon Avenue, August 1994

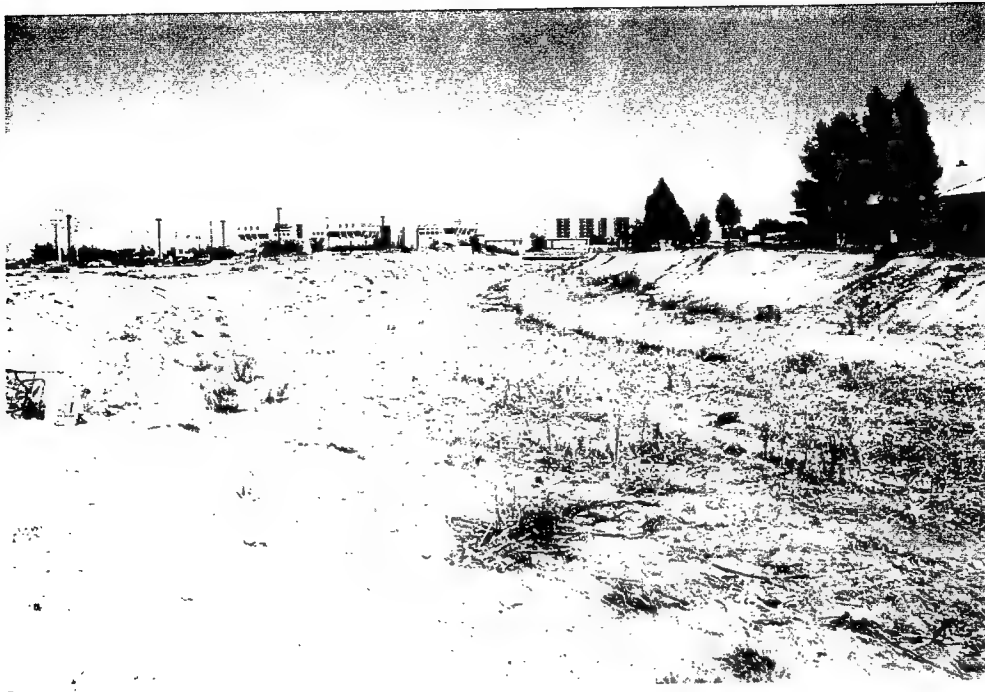
Figure 4. Tropicana Wash - Reach 4, looking downstream from culvert outlet toward Swenson Street, August 1994

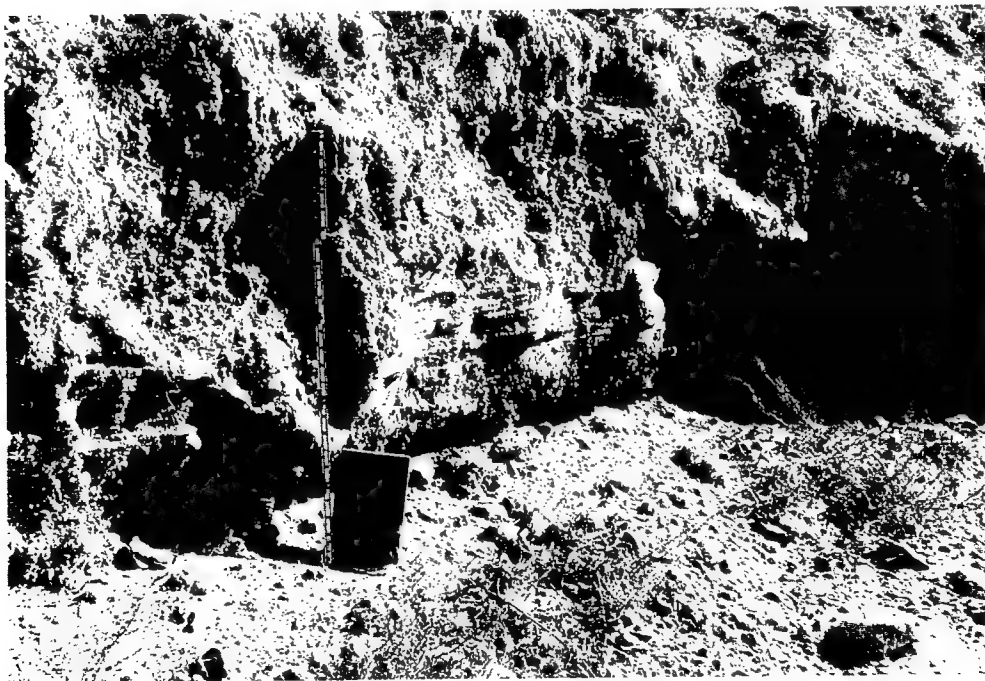
Layered deposits were observed in a three-ft-high vertical cut just upstream from Flamingo Road. As shown in Figures 5 and 6, the lower layer, which was composed of sand and pebbles, was being undercut and had a small detritus deposit at the toe. The sand and pebble layer was covered by a series of layers composed of finer material, another sand and pebble layer, and then additional layers of finer material. This suggests that bank erosion potential along the channel may vary considerably depending on the characteristics of the alluvial deposits that make up the bank at specific locations. These characteristics are typically hidden by channel grading projects and are visible only when erosion exposes the actual bank composition. Considering that the banks in this reach were observed to have layers composed of non-cohesive sand and pebbles, bank erosion potential should be considered high. Materials composing these layers are more easily removed by flowing water and are more subject to blowout by positive pore pressure in the bank than cohesive materials.

Figure 5. Tropicana Wash - Reach 5, vertical cut in right bank just upstream from Flamingo Road, August 1994

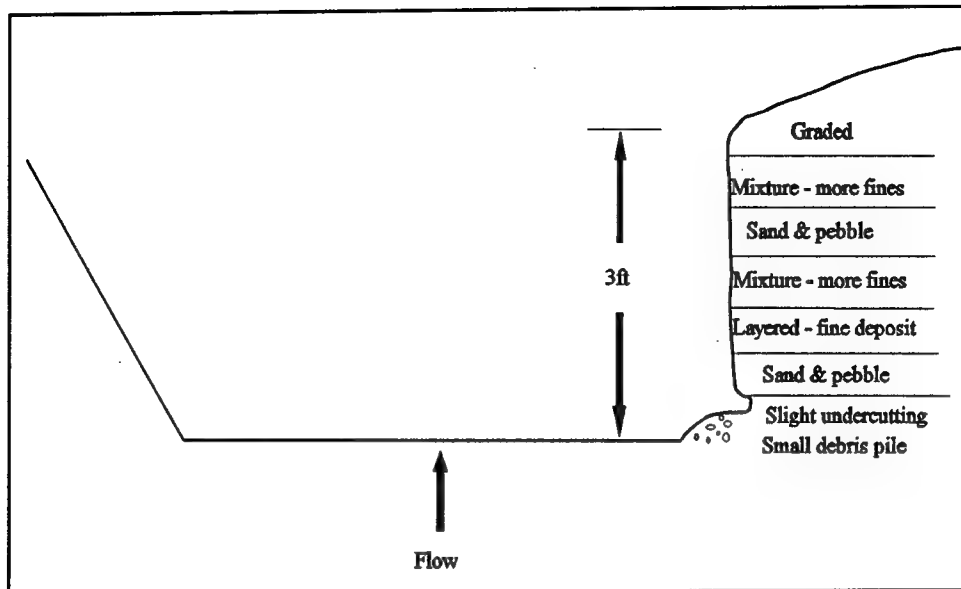
Figure 6. Tropicana Wash - Reach 5, layer description of vertical cut in right bank just upstream from Flamingo Road

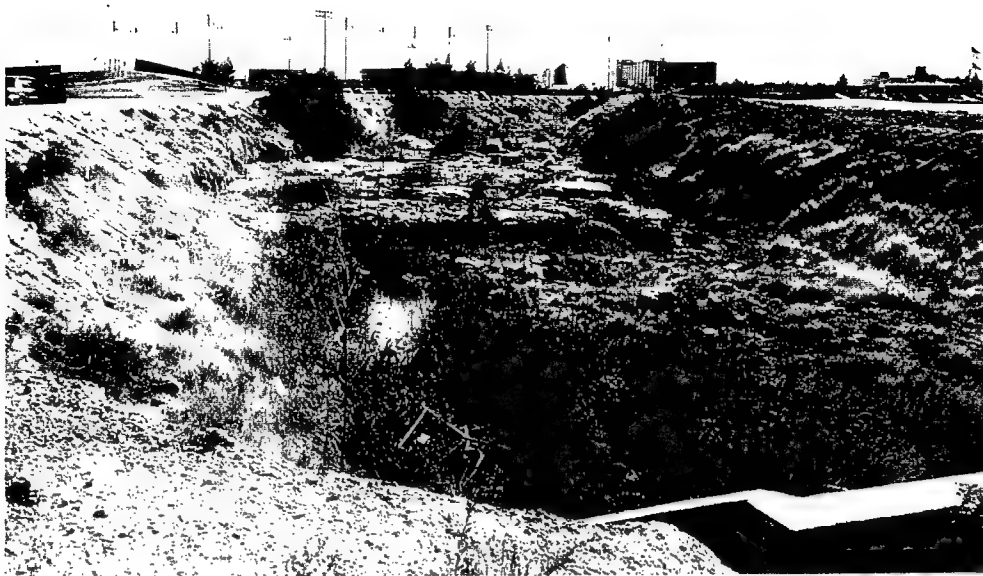
There was a major caliche drop located about 50 ft upstream from Flamingo Road. The total vertical drop was about four feet (Figure 7). The caliche drop demonstrated both the potential for degradation in this reach and the ability of the caliche deposits to form a bed control. Broken caliche fragments were observed downstream from the drop which demonstrated that the deposit was subject to failure and could not be considered a permanent hydraulic control structure. Upstream from this large drop, the caliche outcrops were not visible across the full channel width.

Figure 7. Tropicana Wash - Reach 5, looking upstream from Flamingo Road at caliche bed control, August 1994

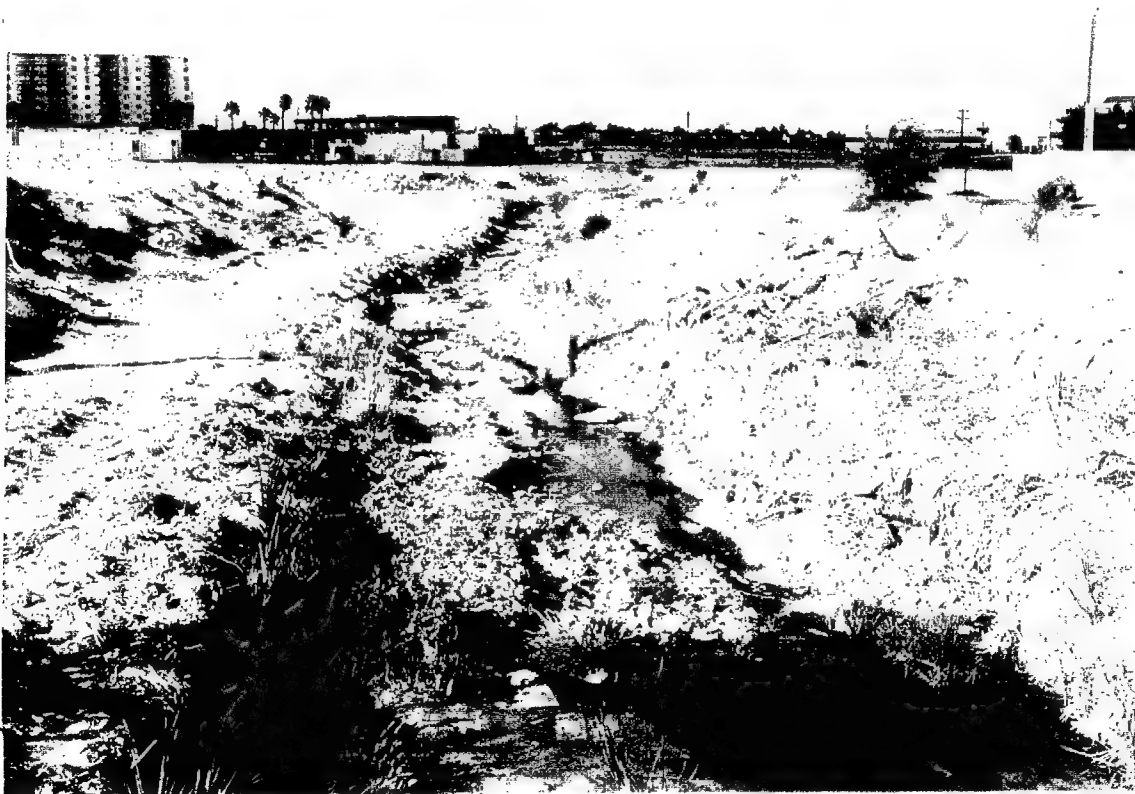
Figure 8. Tropicana Wash - Reach 6, looking downstream from Flamingo Road, April 1995

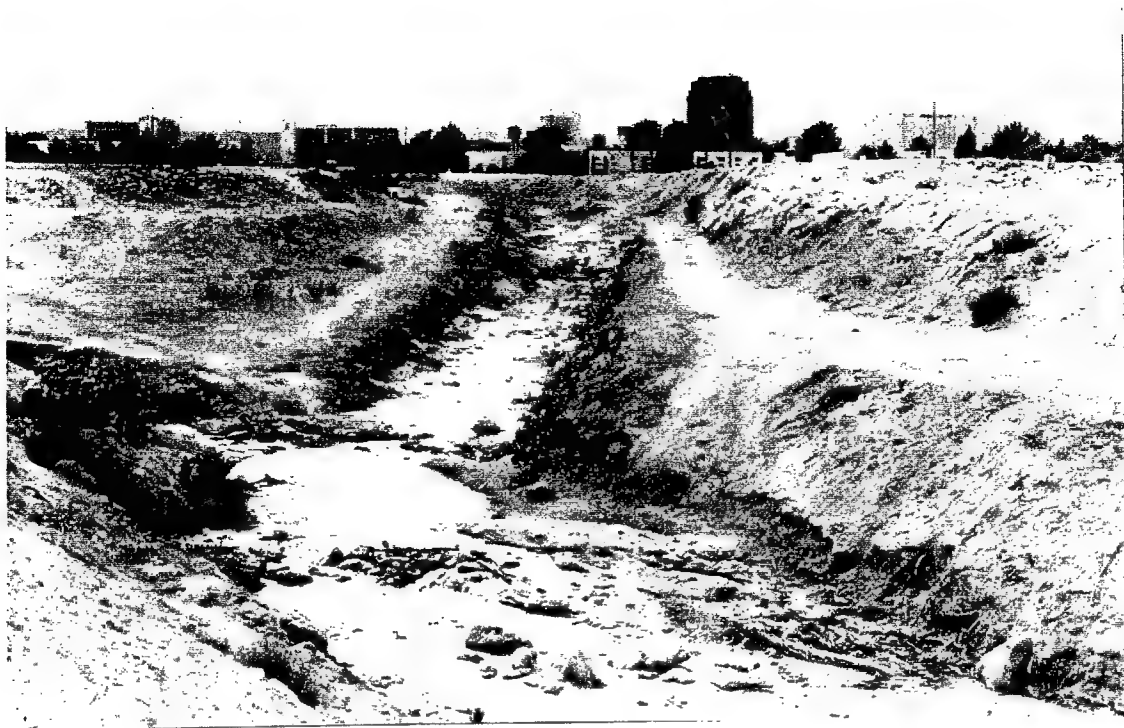
Figure 9. Flamingo Wash - Reach 6, looking upstream from the Tropicana Wash confluence, April 1995

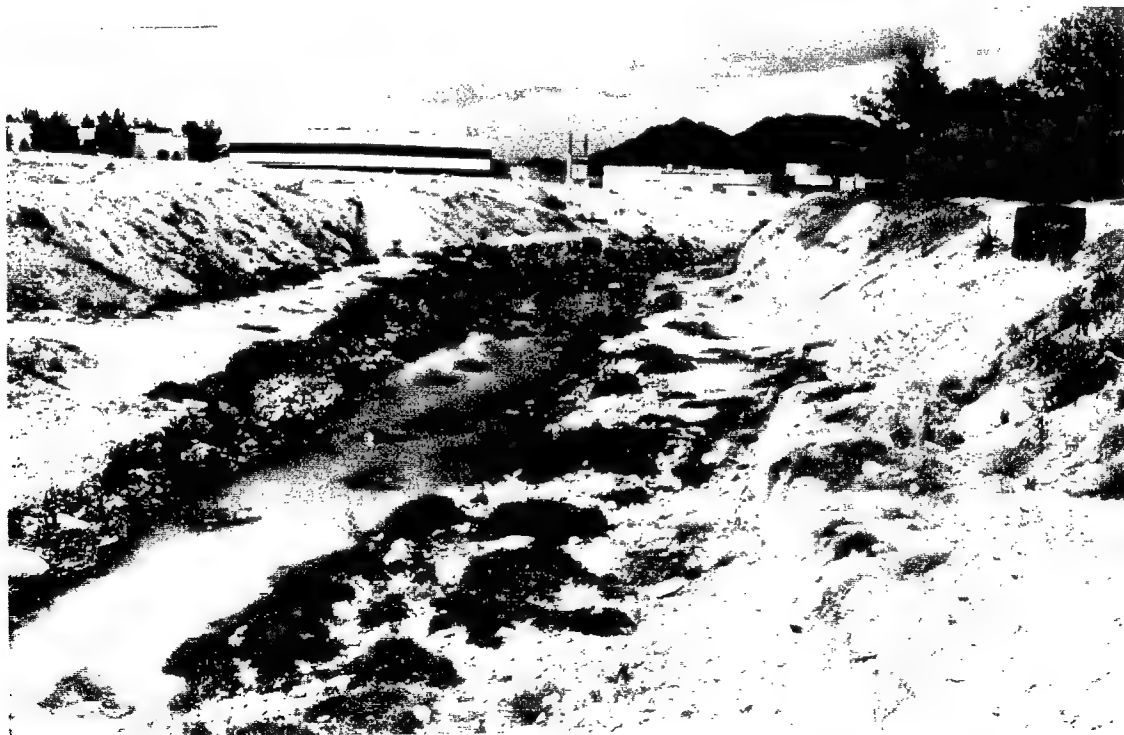
Downstream from Cambridge Street the graded channel generally had a trapezoidal shape with a 10-ft-wide low-flow channel cut to a depth of 4 to 5 ft (Figure 10). The nearly vertical upper banks consisted of sand and gravel. The bank material was quite hard even though the presence of significant cohesive material was not apparent. The upper layers of these banks were composed of loose material. Concrete-lined bank protection extended about 100 ft upstream from Maryland Parkway on the right bank, and about 300 ft upstream on the left bank. The concrete-lined side slopes were not keyed into the bed. Generally, the bottom elevation of the slab was at the existing channel bed elevation. However, erosion had occurred at the base of the lined side slopes at several locations (Figure 11). Further erosion could undercut the slabs and cause failure along a significant reach of the channel. Geometric irregularity associated with slab failure would accelerate the local erosion process. A plan view of reach 7 is shown in Plate 7.

Figure 10. Flamingo Wash - Reach 7, looking downstream from Cambridge Street, April 1995

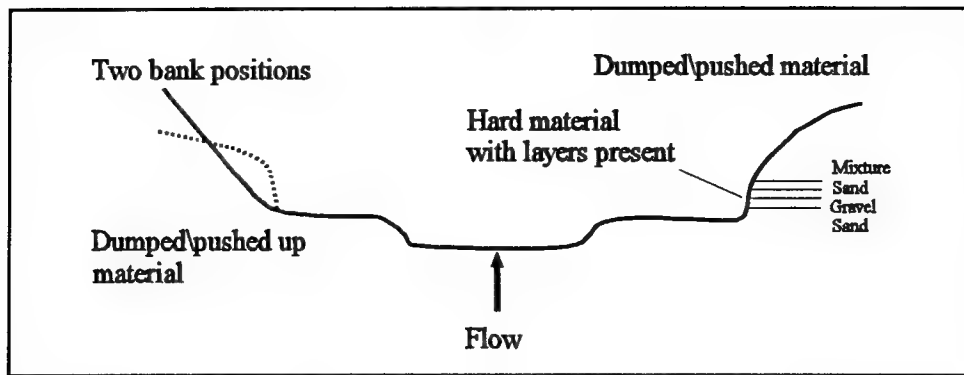
Figure 13. Flamingo Wash - Reach 8, Typical channel cross section between Maryland Parkway and concrete-lined channel

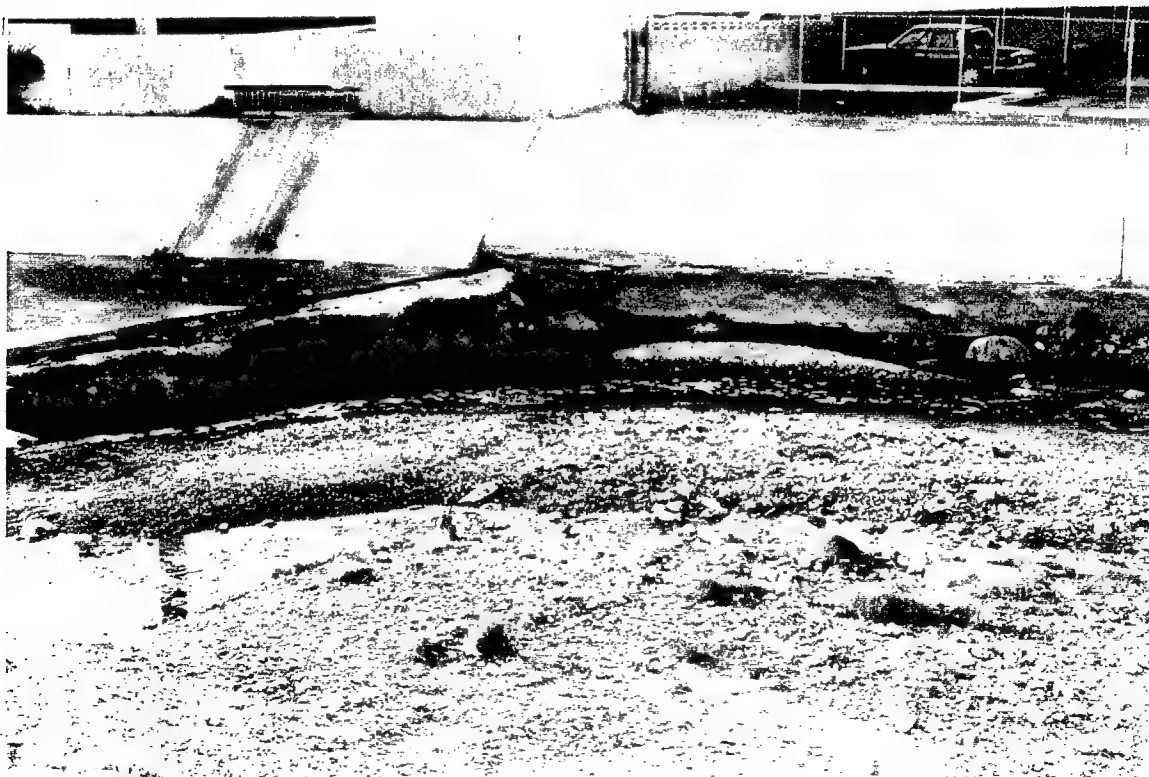
Figure 15. Flamingo Wash - Reach 8, erosion at end of concrete-lined channel, April 1995

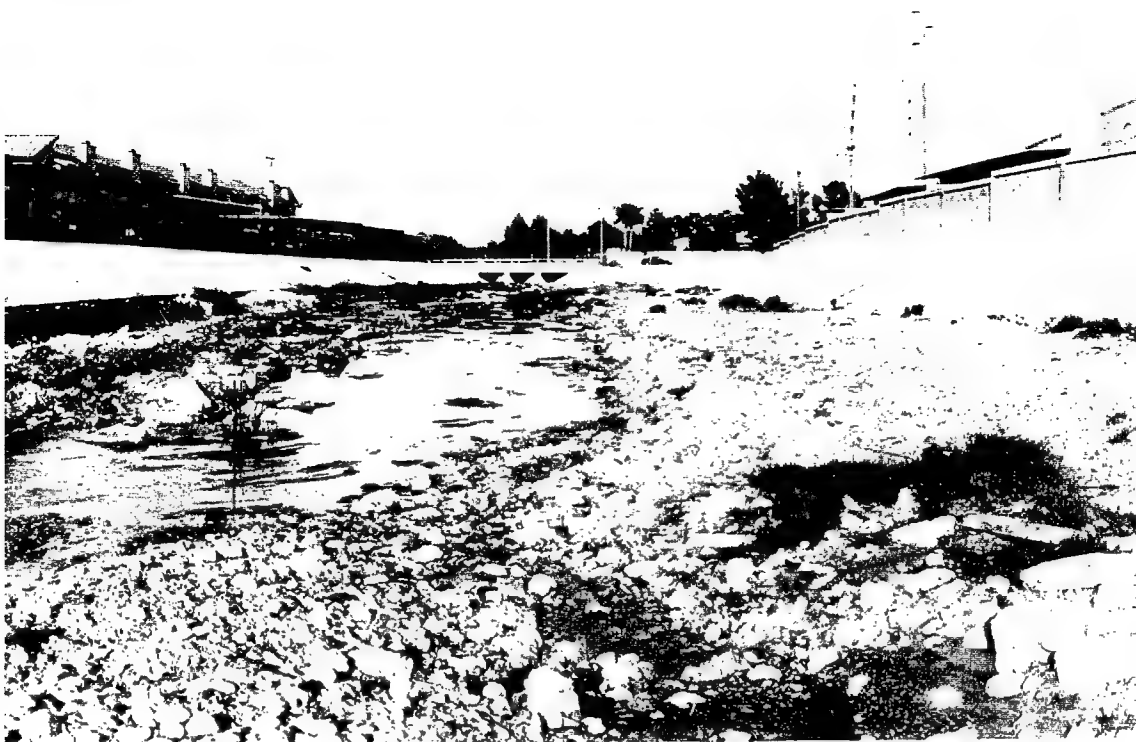
Downstream, the remaining 800-ft of reach 8 had a trapezoidal channel with concrete-lined side slopes and a natural invert (Figure 16). The natural invert had sparse grass on the bed, and a low flow channel had developed to a depth of about 1 ft in August 1994. Degradation of about 2 to 3 ft had occurred below the toe of the concrete side slopes at some locations. No evidence of concrete footings was observed. By March 1996, berms had been constructed from imported angular gravel-sized material along both banks throughout this reach. Just upstream of Spencer Street there was a concrete access road that faced upstream on the right bank. This would act as a launch for flood flows.

Figure 16. Flamingo Wash - Reach 8, looking downstream toward Spencer Street, April 1995

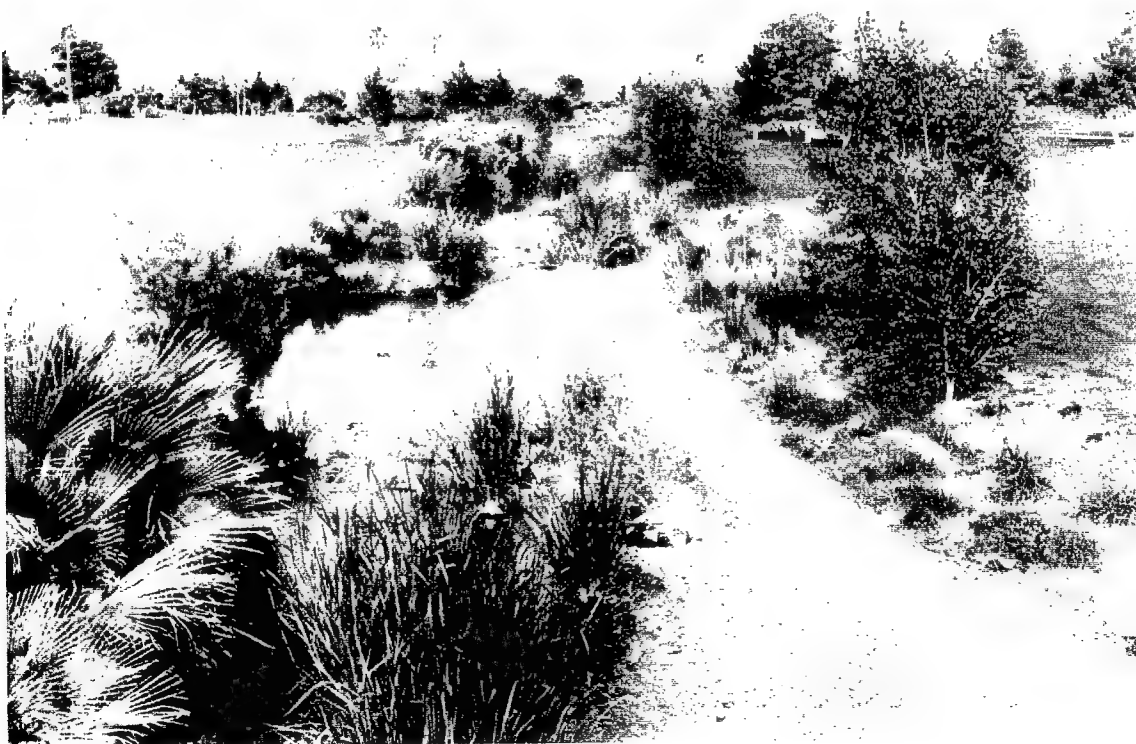
Downstream from the Spencer Street culvert was a short transitional channel leading into a more natural channel through a golf course. The first 150 ft downstream from the culvert had concrete-lined side slopes and an unprotected invert. There was a 2.5-ft-high sill at the end of the concrete-lined side slopes. Downstream from the sill the banks were composed of loose graded material. The channel bed through the golf course appeared to be unmaintained with significant vegetation. Gravel bars were observed in the bed. The mild sloping banks were covered with well maintained grass (Figure 17).

Figure 17. Flamingo Wash - Reach 9, looking downstream through golf course, near Spencer Street, April 1995

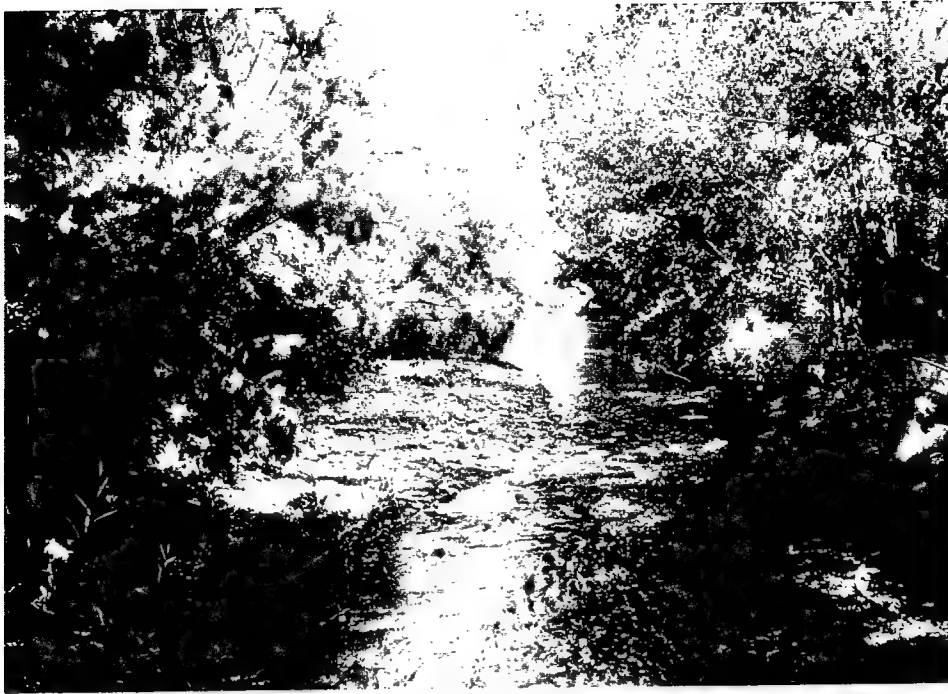
About 900 to 600 ft upstream from McLeod Drive a short canopied reach was observed which had a 10-ft-wide gravel bed and tree-covered banks (Figure 18). The right bank consisted of dumped material. A caliche outcrop was observed in the bed.

Figure 18. Flamingo Wash - Reach 10, canopied channel just upstream from McLeod Drive, August 1994

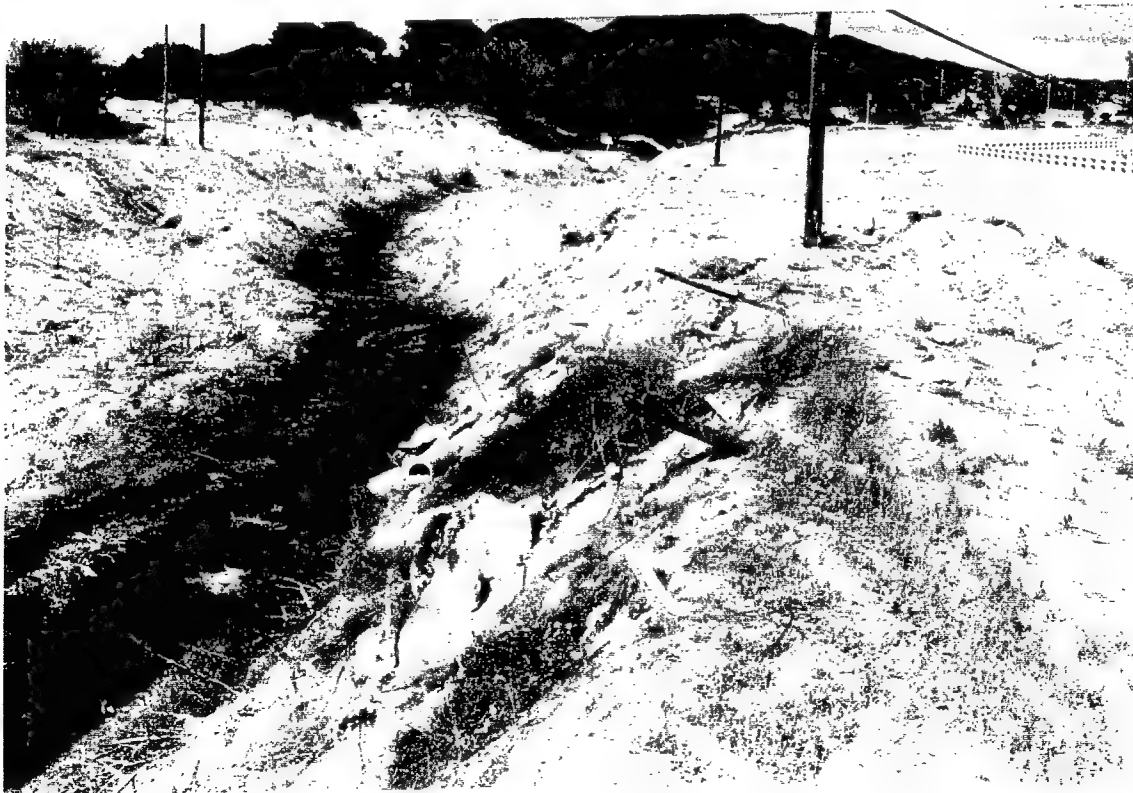
equipment. However, broken caliche fragments were present in the bed at several locations along the reach. The bank material was very loose. This reach has a very high potential for erosion and instability (Figure 19).

Figure 19. Flamingo Wash - Reach 10, looking downstream, about halfway between Eastern Avenue and McLeod Drive, April 1995

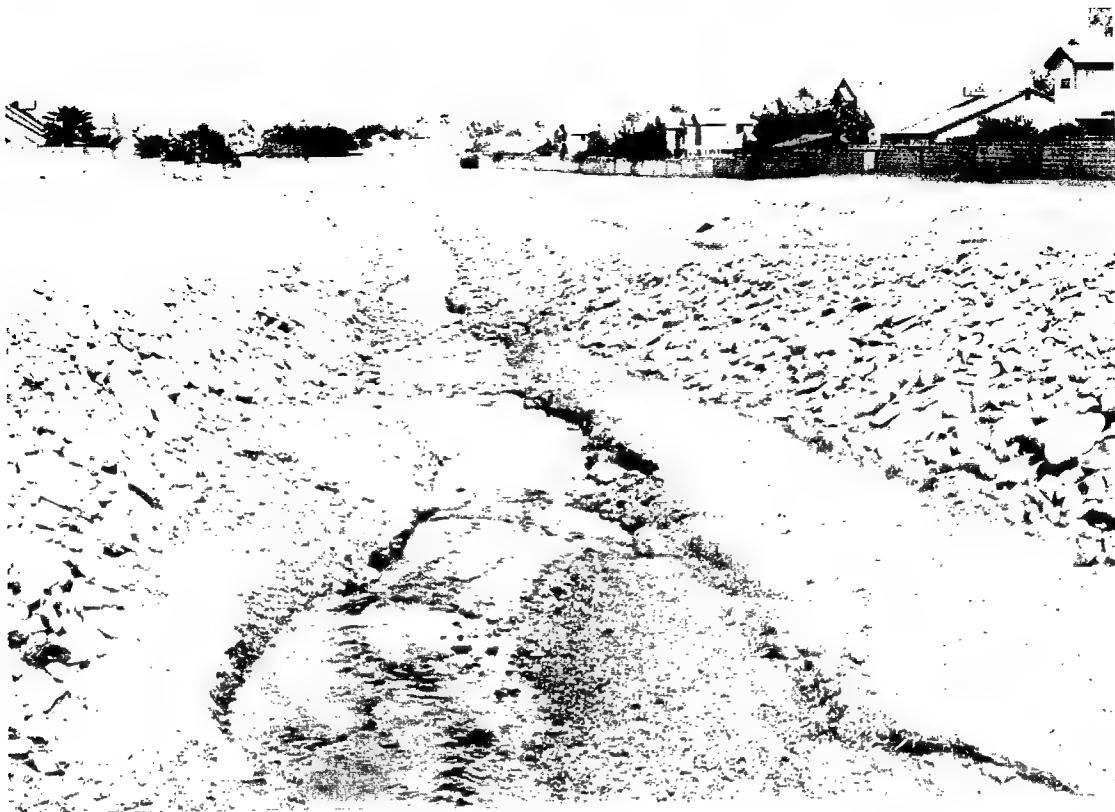
Downstream from Mojave Road was a shaped trapezoidal channel with a low-flow channel about 8 ft deep by 20 ft wide (Figure 20). Riprap had been placed on the right outer bank of the low-flow channel. A mobile armor layer was present in the bed at some locations. A caliche control with a 1.5-ft drop was located about 1300 ft downstream from Mojave Road near a local drainage inlet. A point bar had developed downstream from the caliche outcrop. Bank erosion was observed in the low-flow channel in areas without riprap protection. Between August 1994 and April 1995 the longitudinal extent of the riprap protection in the low-flow channel had been increased significantly. Bank erosion observed at several locations in August 1994 had been repaired. In unprotected reaches, there was a natural meander pattern present in the low-flow channel that had a much smaller wave length than the main channel curvature. This resulted in bank erosion on the inside of the channel bed as shown in Figure 21. The composition of the low-flow channel banks in this reach was varied. There was sand in the lower layers, and either weakly cemented sand and gravel or just loose sand and gravel in the upper layers. The bank angles observed were relatively steep, which was surprising considering the non-cohesive appearance of the bank material. The banks seemed natural but asphalt and trash were present. The banks may have been shaped using dumped material and then reworked by the stream, resulting in the layered appearance.

Figure 20. Flamingo Wash - Reach 13, looking downstream from Mojave Road, April 1995

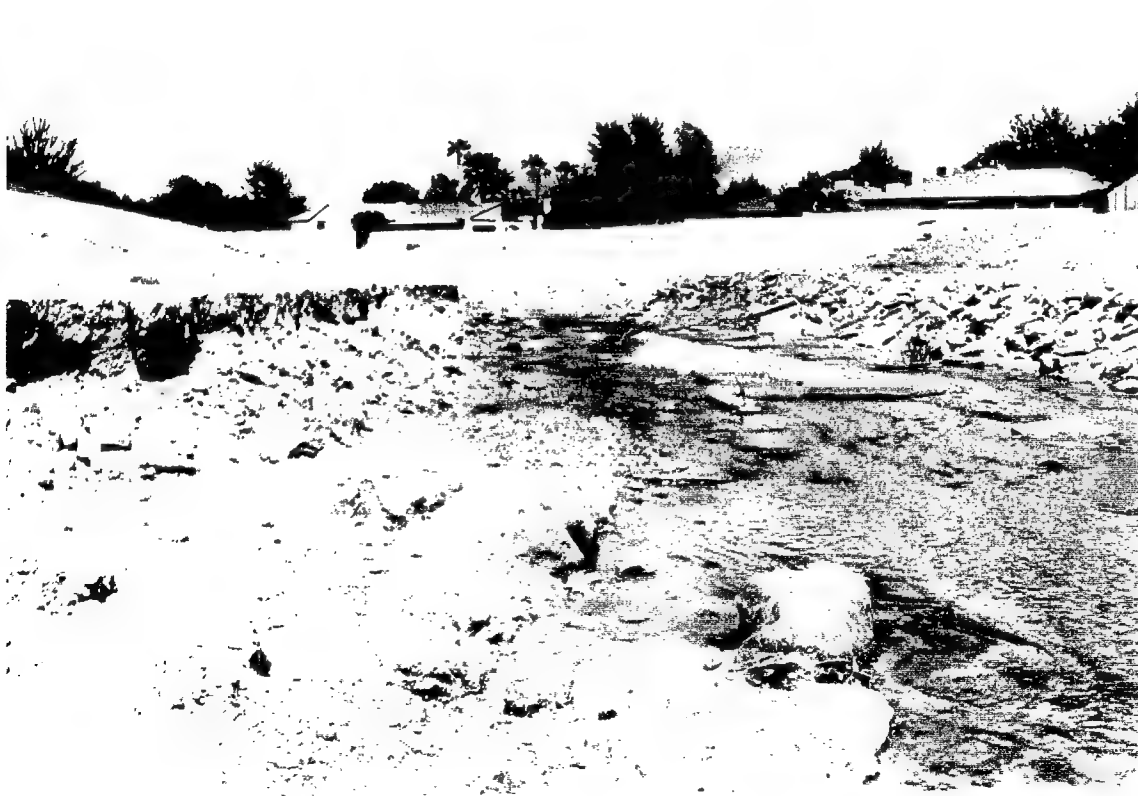
Figure 21. Flamingo Wash - Reach 13, downstream from Mojave Road looking at erosion on inside of channel bend, April 1995

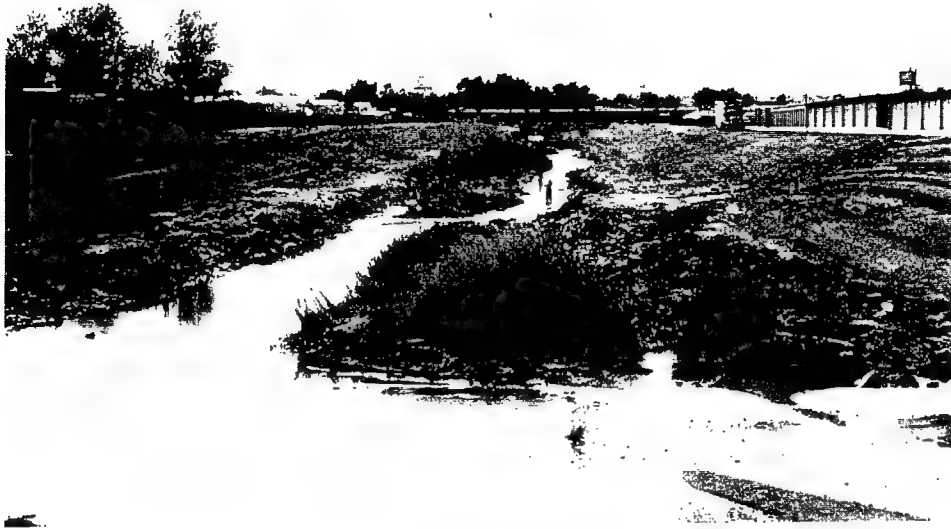
Downstream from Interstate 515 was a graded trapezoidal channel with a cut low-flow channel. The low-flow channel became more poorly defined as it approached Lamb Boulevard. The main channel in this reach was wider, and the banks were not as steep as further upstream. In August 1994 meandering was observed in the 1- to 2-ft deep and 30- to 40-ft wide low-flow channel. Gabions placed on the right bank, just downstream from Interstate 515, were in danger of failing due to backwashing. Other than this short reach of gabions there was no bank protection in the reach. In August 1994 grass that had been growing in the channel bed was yellow and appeared to have been recently sprayed with herbicide. The low-flow channel had been reshaped by April 1995, removing signs of deposition and meandering (Figures 22 and 23).

Figure 22. Flamingo Wash - Reach 16, looking upstream from Lamb Boulevard, August 1994

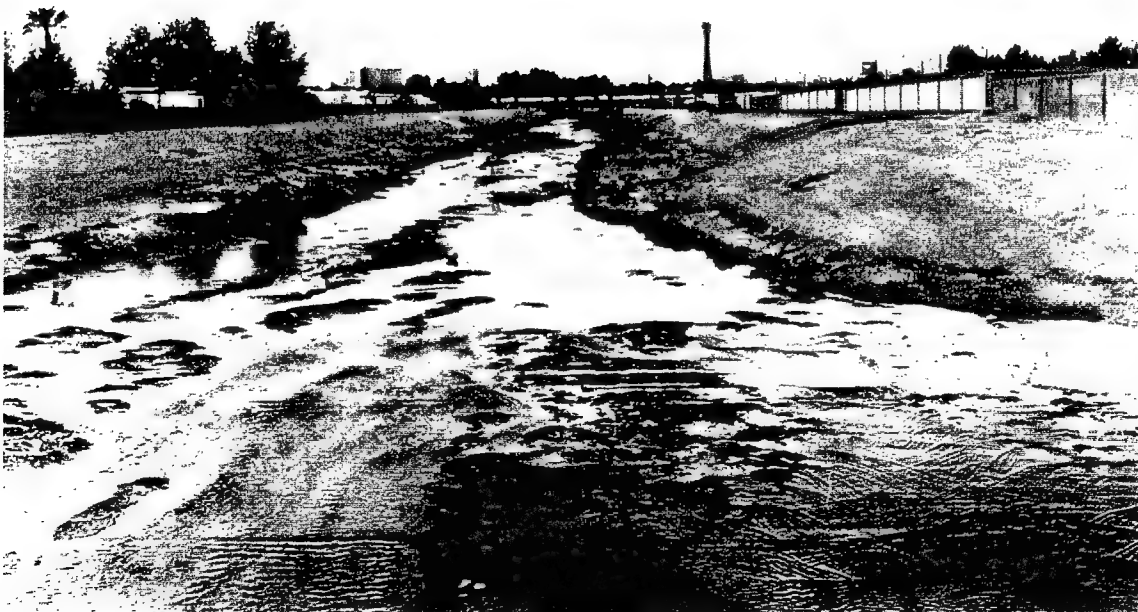
Figure 23. Flamingo Wash - Reach 16, looking upstream from Lamb Boulevard, April 1995

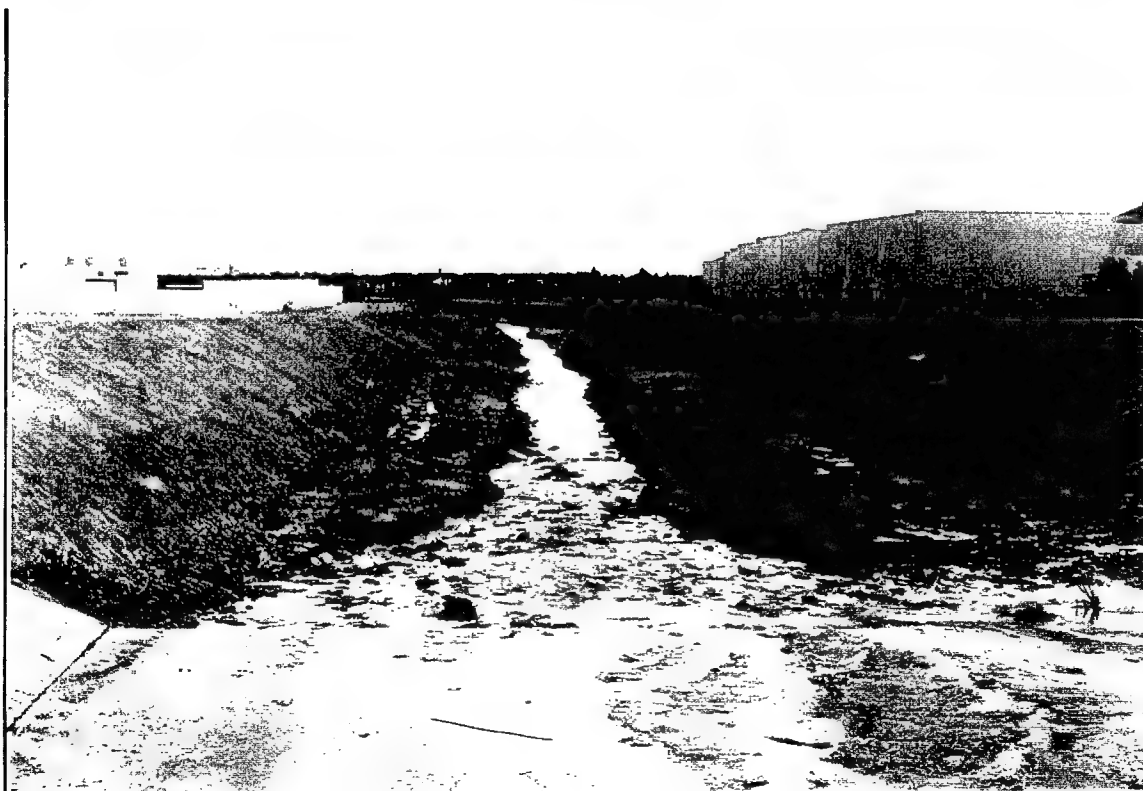
Figure 25. Flamingo Wash - Reach 17, looking downstream from Lamb Boulevard, April 1995

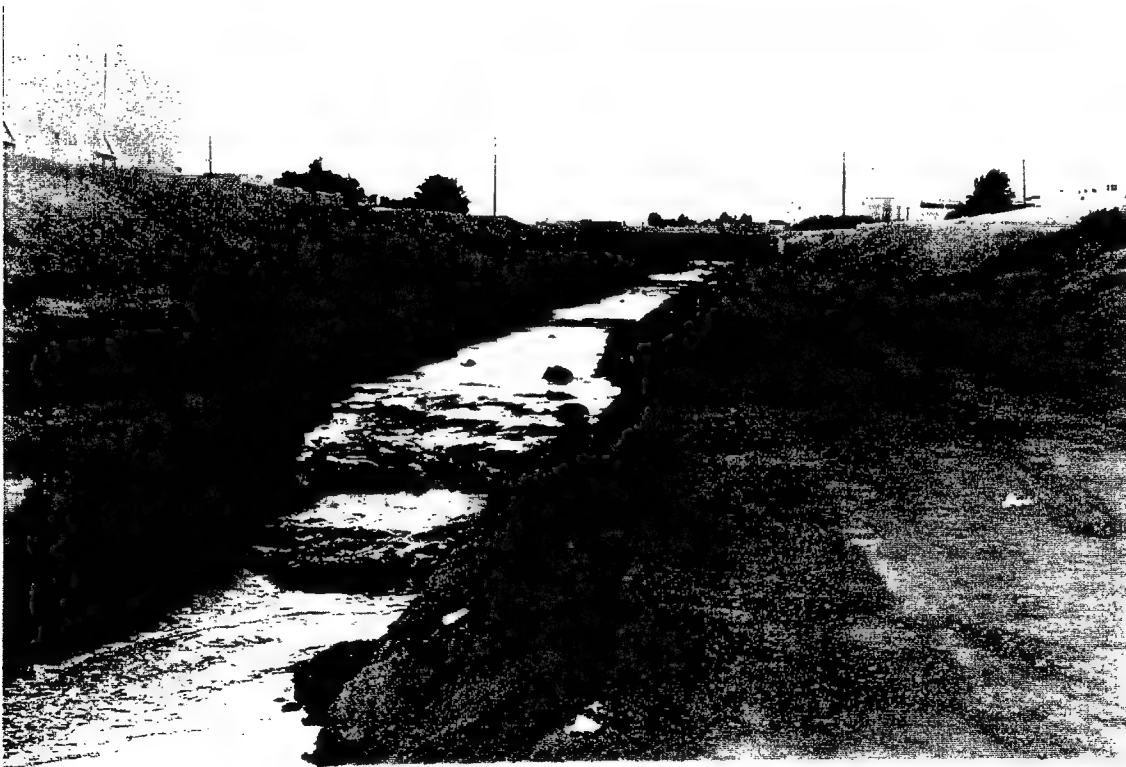
Figure 27. Flamingo Wash - Reach 17, caliche headcut, April 1995

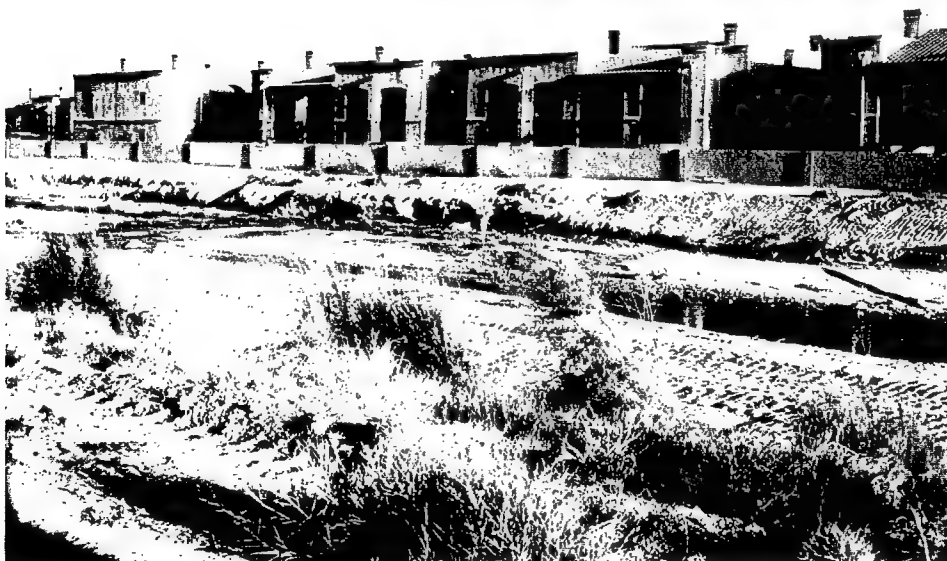
Figure 29. Flamingo Wash - Reach 17, erosion on right bank, upstream from Nellis Boulevard, August 1994
